Garmin 18X – 5hz Update

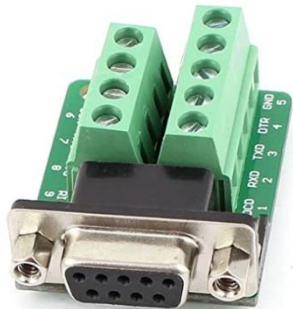
DB-9 serial connector female

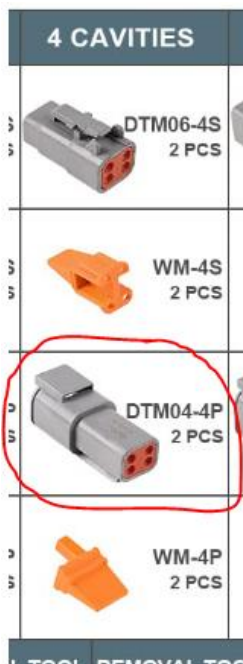
Deutsche DTM – 4 Pin connector – sold complete with both halves – male only required

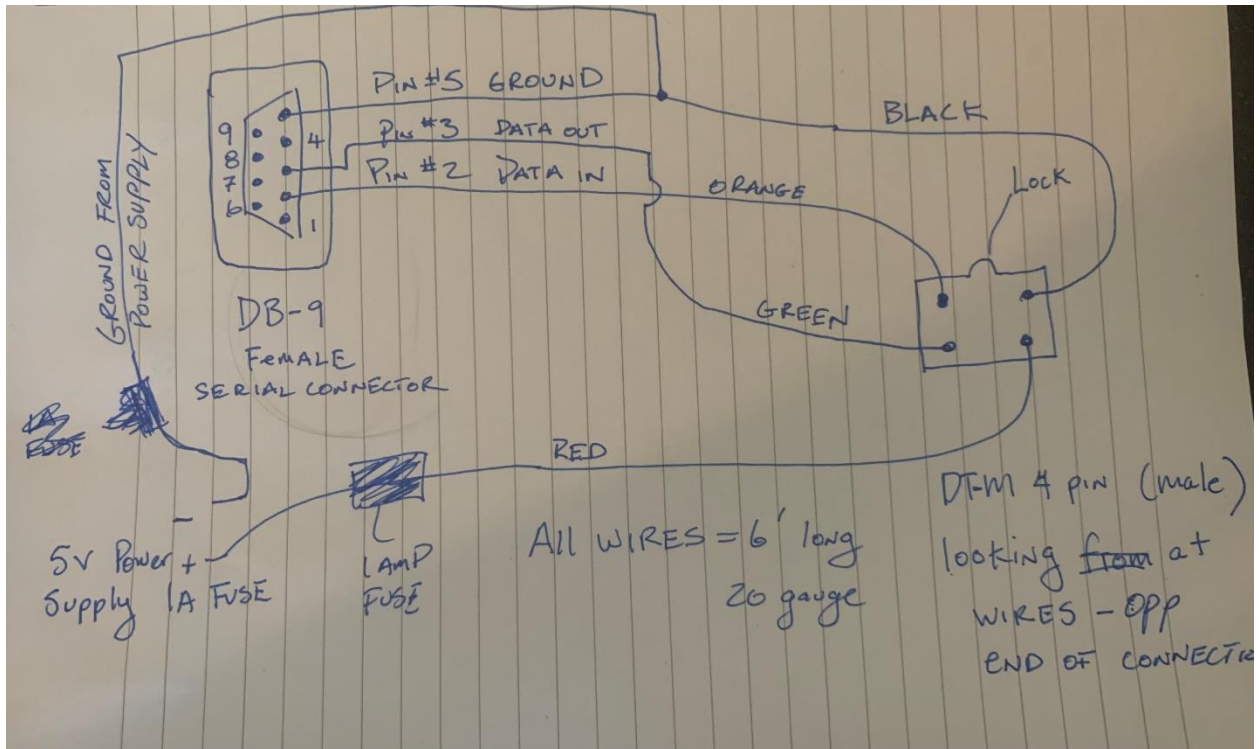
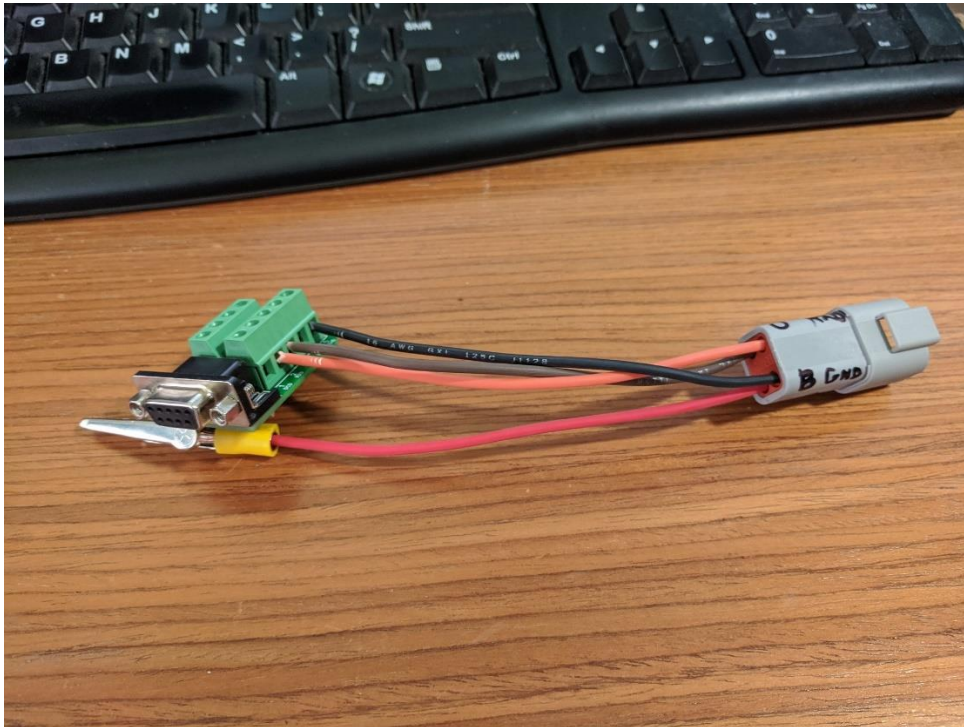
Wiring:

Note: brown wire goes to green on Zero Off harness (these wires should be 6' long for in-boat updating)
